Leon Environmental Services

**Re: Asbestos Survey Report
Old Cold Storage Building Behind Reedley City Hall
845 G Street, Reedley, CA
Job No. S25-14**

BUILDING DESCRIPTION

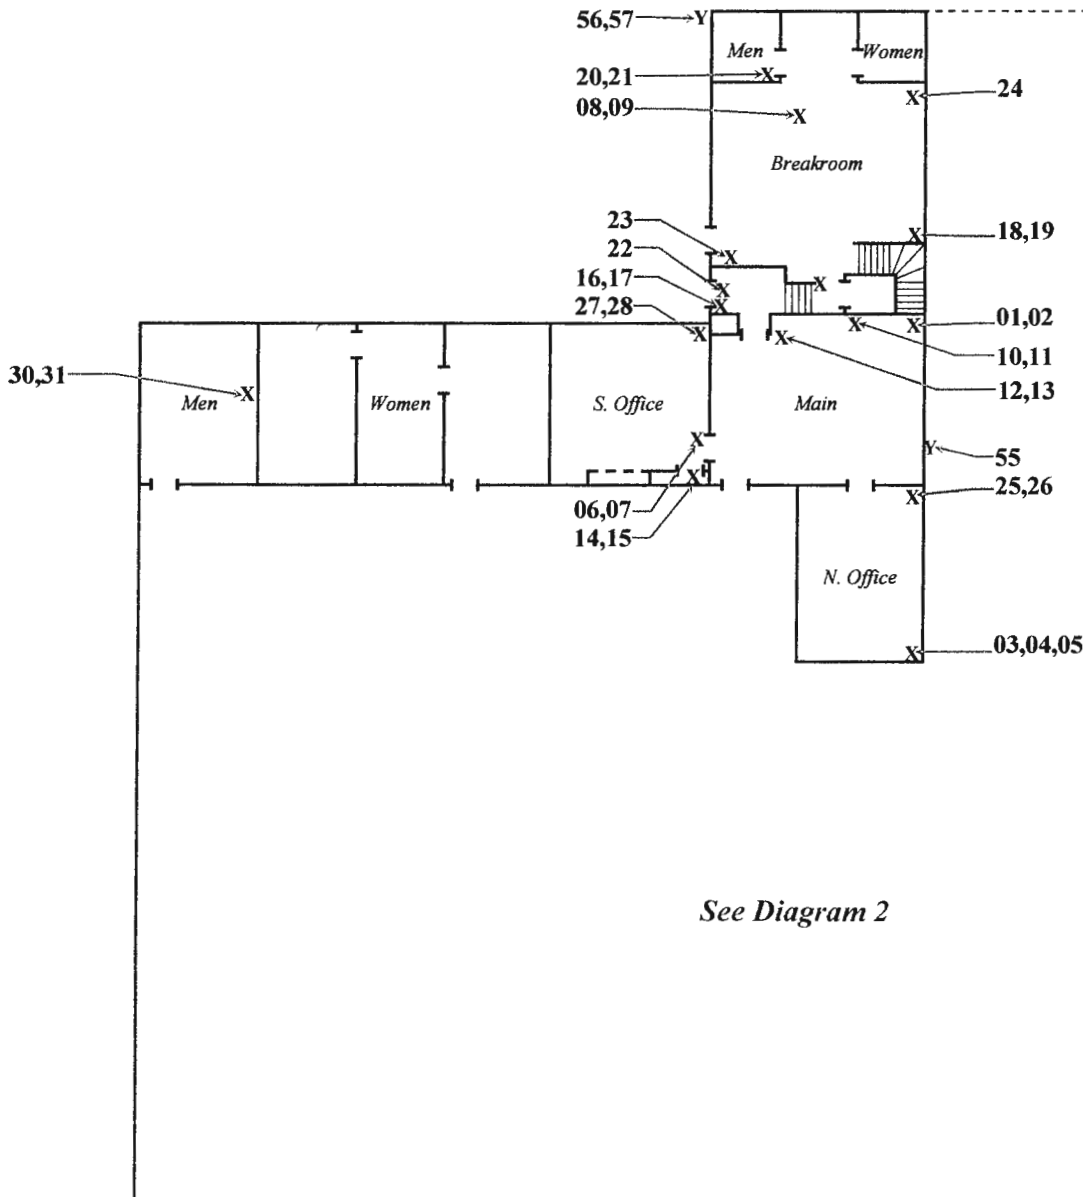
Job S25-14 Sample Location Diagram 1
Cold Storage Building / 845 G. St, Reedley, CA
Wes Isaac / Wes Isaac Construction
Drawing not to Scale

The dark 12x12 floor tile (sample 01) and associated black mastic (sample 02) in the main detective office are positive for asbestos at greater than 1% and 3-4% respectively by weight. Floor tile and floor tile mastics are considered **non-hazardous non-friable ACM** and can be disposed of as construction waste in most cases after properly being abated. Leon Environmental Services recommends that a licensed asbestos abatement contractor remove this material prior to renovation and or demolition of this structure. **374 sq ft**

The brown 9x9 floor tile (sample 04) under the carpet in the north detective office, and the grey 9x9 floor tile (sample 06) in the south detective office are both positive for asbestos at greater than 1% by weight. The associated mastics for these VAT's are negative for asbestos. Floor tile is considered **non-hazardous non-friable ACM** and can be disposed of as construction waste in most cases after properly being abated. Leon Environmental Services recommends that a licensed asbestos abatement contractor remove these materials prior to renovation and or demolition of this structure. **490 sq ft**

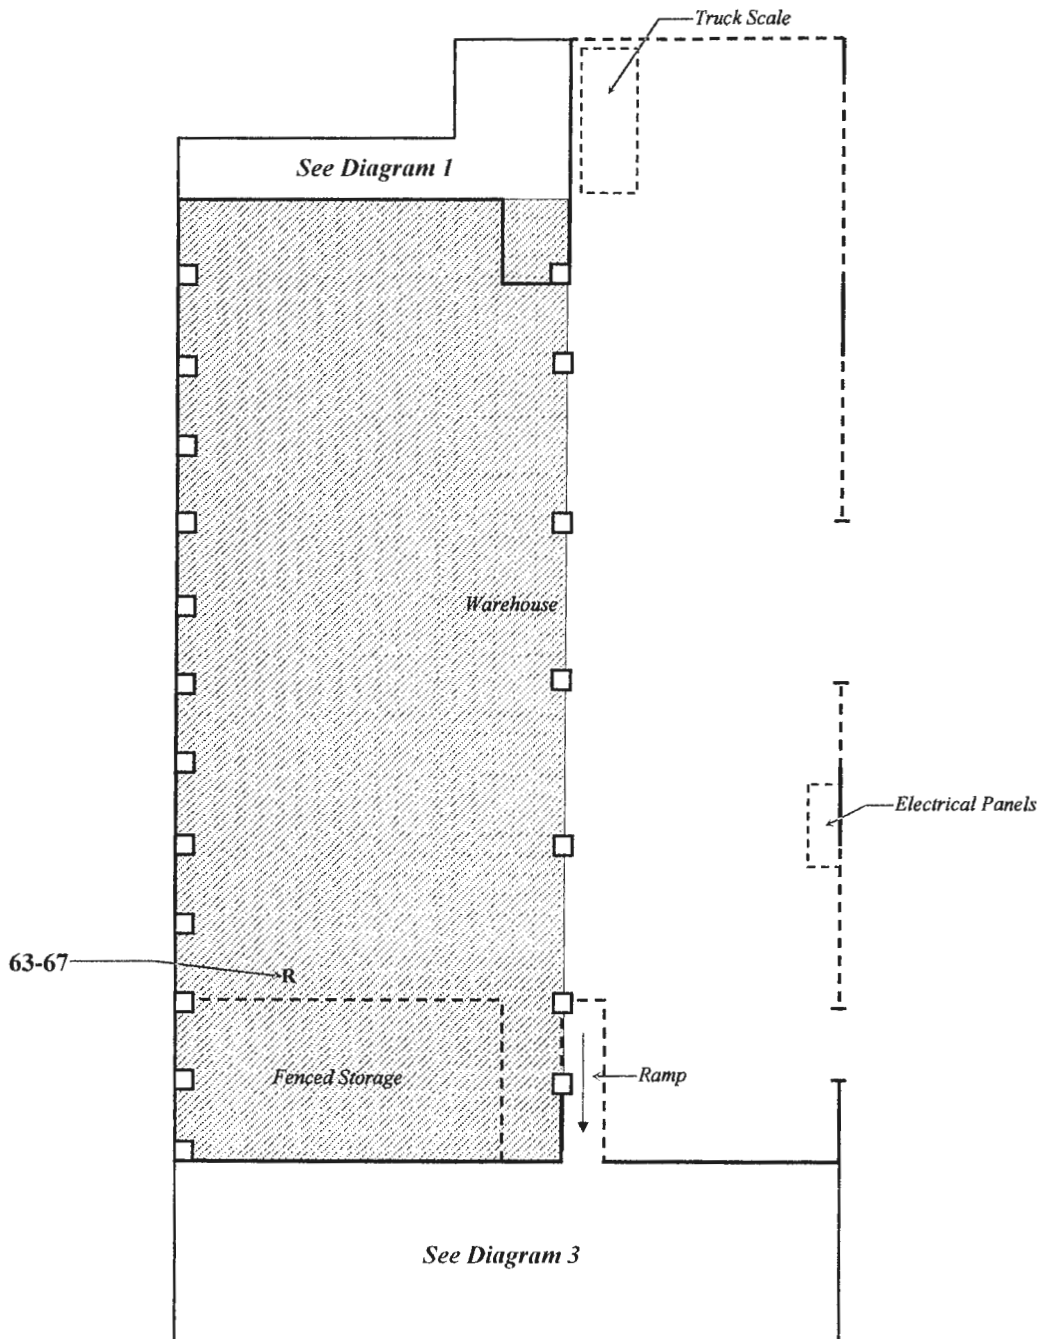
Job S25-14 Sample Location Diagram 2
Cold Storage Building / 845 G. St, Reedley, CA
Wes Isaac / Wes Isaac Construction
Drawing not to Scale

The bottom layers of roofing felts (samples 67a, 67b) on the on the west barrel roof are positive for asbestos at 40% by weight. Roofing materials are considered **non-hazardous non-friable ACM** and can be disposed of as construction waste in most cases after properly being abated. It is recommended that a licensed asbestos abatement contractor remove these materials prior to renovation and or demolition of this structure. **16,000 sq ft**

The roof mastic (sample 68) on the seams and vents of the west barrel roof is positive for asbestos 10% by weight. Roof mastic and sealants are considered **non-hazardous non-friable ACM** and can be disposed of as construction waste in most cases after properly being abated. It is recommended that a licensed asbestos abatement contractor remove this material prior to renovation and or demolition of this structure. **100 sq ft**

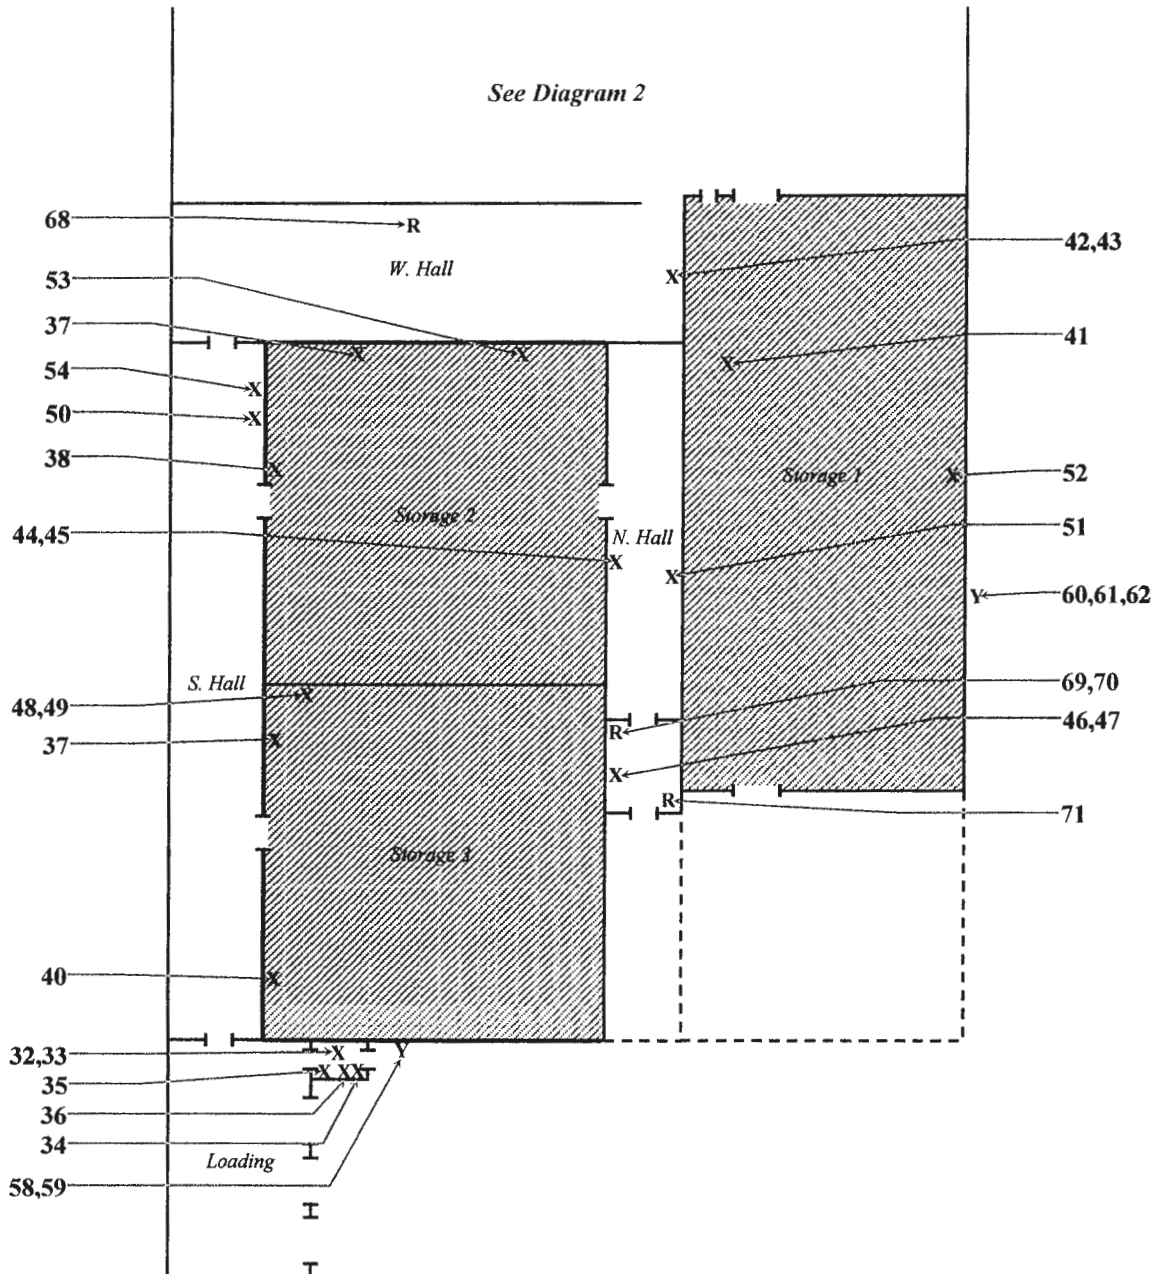
Job S25-14 Sample Location Diagram 3
Cold Storage Building / 845 G. St, Reedley, CA
Wes Isaac / Wes Isaac Construction
Drawing not to Scale

The plaster-like texture on the spray foam (samples 37, 38, 39, 40, 41) on the walls & ceilings in cold storage rooms 2 & 3 and the ceiling in cold storage room 1 is positive for asbestos at 2% by weight. This material is considered **friable hazardous ACM** and must be handled and disposed of accordingly. Leon Environmental Services recommends that a licensed asbestos abatement contractor removes these materials prior to renovation and or demolition of this structure. **20,000 sq ft**
